CRASHTALK GR

SUV - Have You Rolled One Lately?

Reconstructing a "T-Bone" Collision

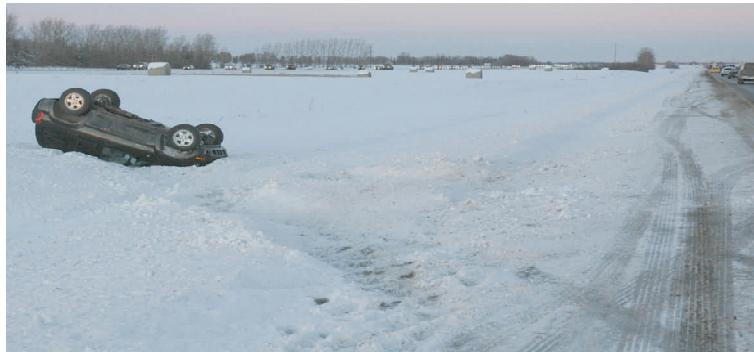
First and foremost, an SUV is NOT a replacement for winter tires. Even though SUV's may out-accelerate two-wheel drive cars in slippery conditions, their braking and steering are not generally superior. In fact, an SUV tends to trip and roll sideways on soft soil at 30 km/h, whereas most cars will remain upright.
